## **Failure Analysis in Space: International Space Station (ISS) Starboard Solar Alpha Rotary Joint (SARJ) Debris Analysis**

Space Shuttle mission STS-117 delivered the S3/S4 truss segment to the ISS, which included a SARJ that rotates 360° to position the solar arrays facing the sun. Three months after installation, vibration was observed in a camera mounted on the SARJ, and an investigation commenced to find the source. Debris was collected from the starboard SARJ during an extra-vehicular activity (EVA) of STS-120 and returned to the Kennedy Space Center so that a remote failure analysis could be performed on Earth. A plan was formulated to identify the source of the debris and to determine the failure mechanism. This presentation will show the data from the analysis—including stereomicroscopy, scanning electron microscopy, energy dispersive spectroscopy, and laser confocal microscopy—and interpret the data in support of the failure analysis. The debris originated from the race ring and failure of the fragments appeared to be the result of contact stress fatigue.

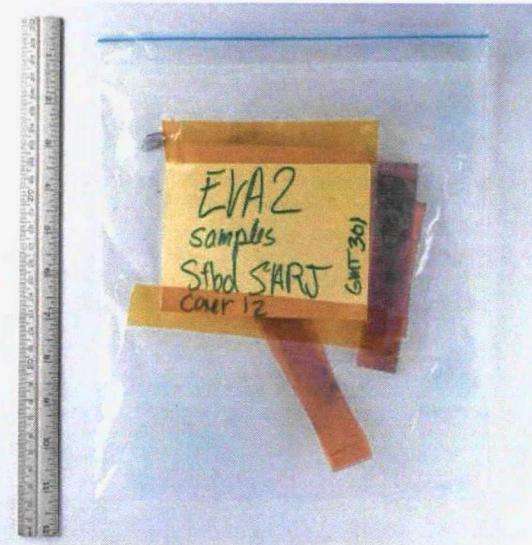
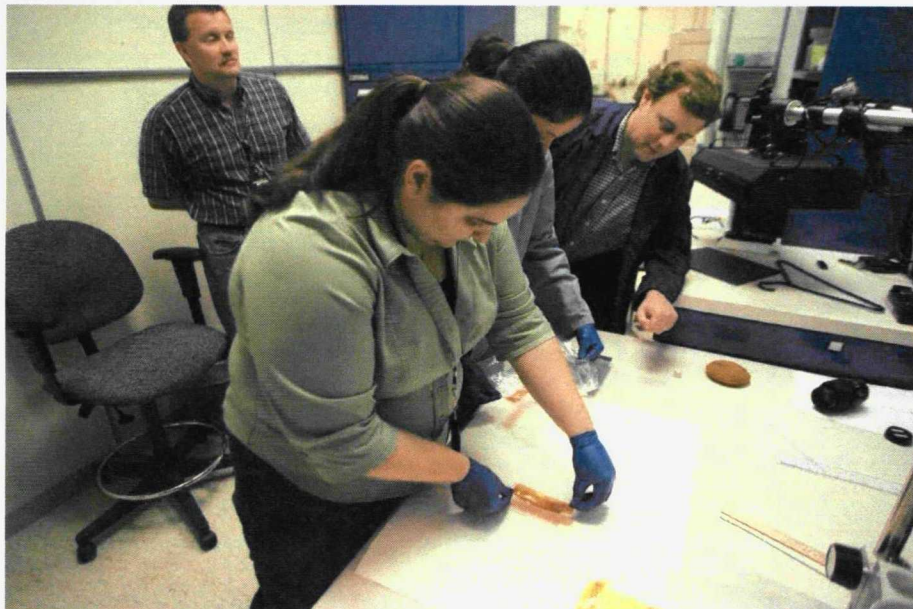
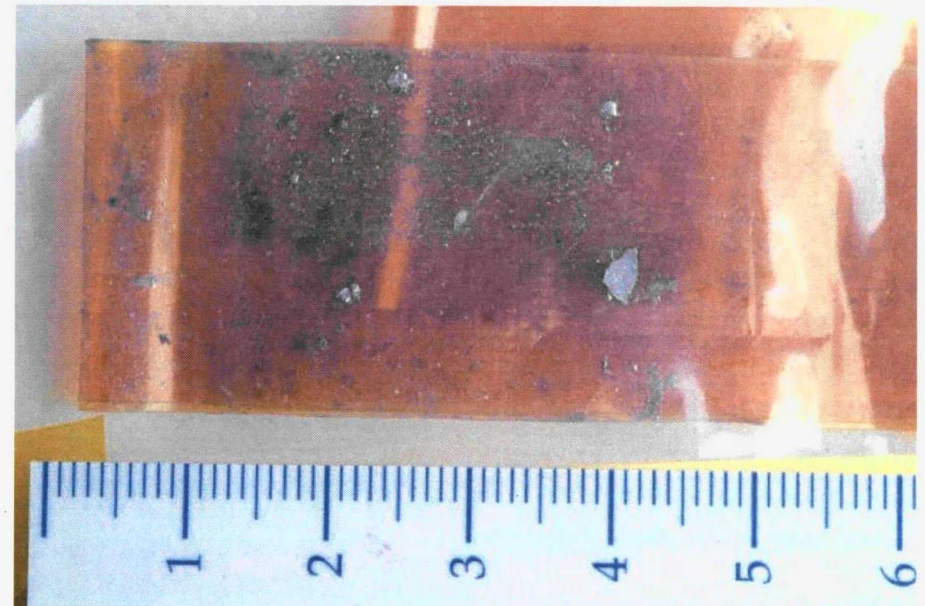
Representative particles from the tapes.

6.3X

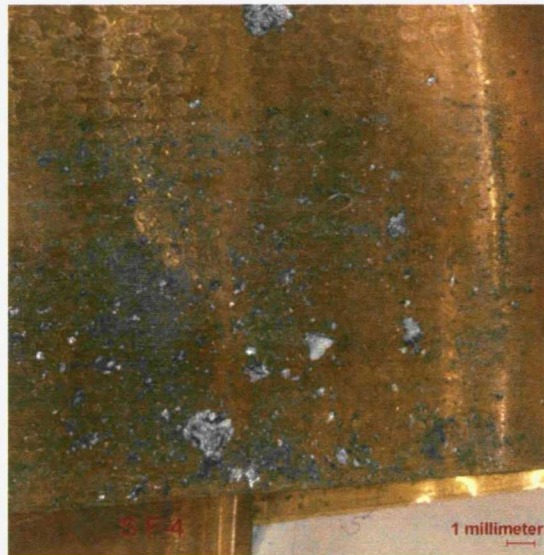
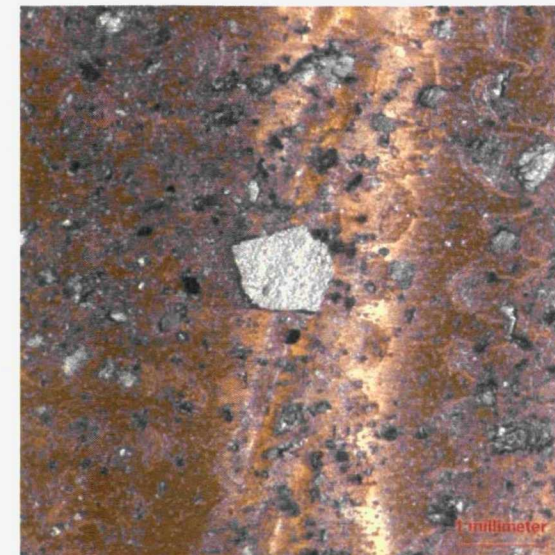
20X

- Wide particle size distribution.
- Distinct particle morphologies.
- Scale bars are 1mm.

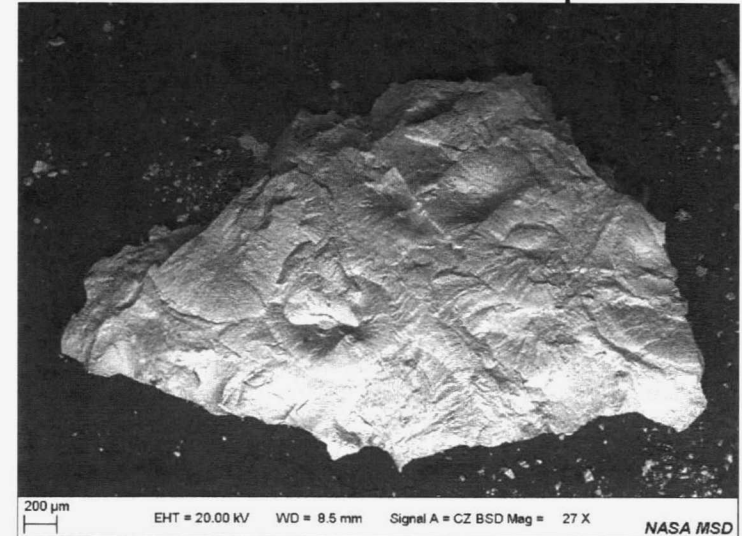
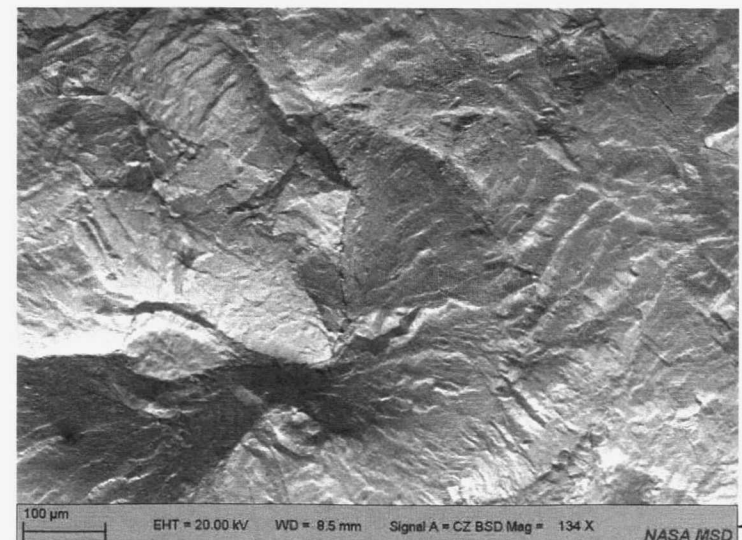
Secondary electron (SE) SEM image of a fragment removed from tape and imaged under high vacuum.

Area in red box appears to be a fracture initiation site and elliptical region suggests crack arresting. Features typical of spalled fragments.

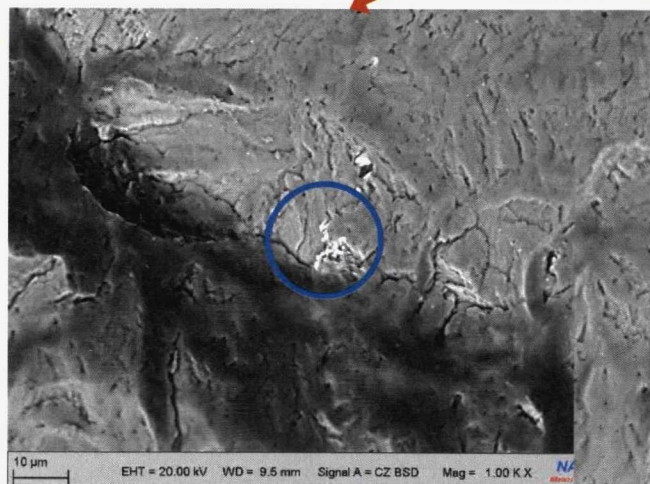
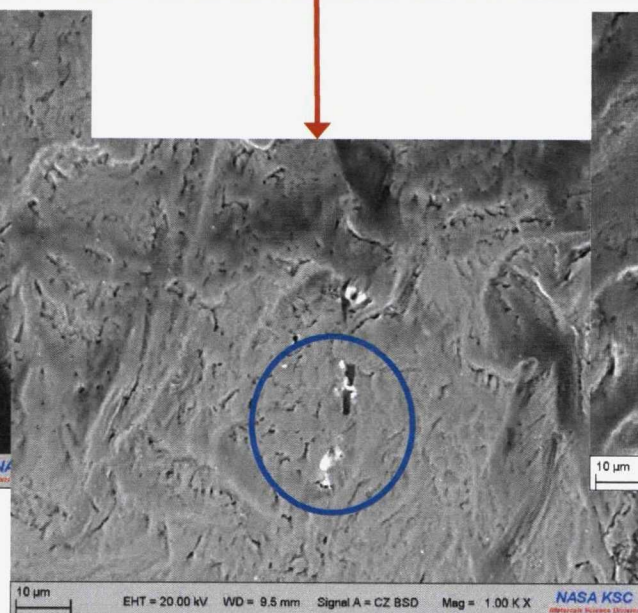
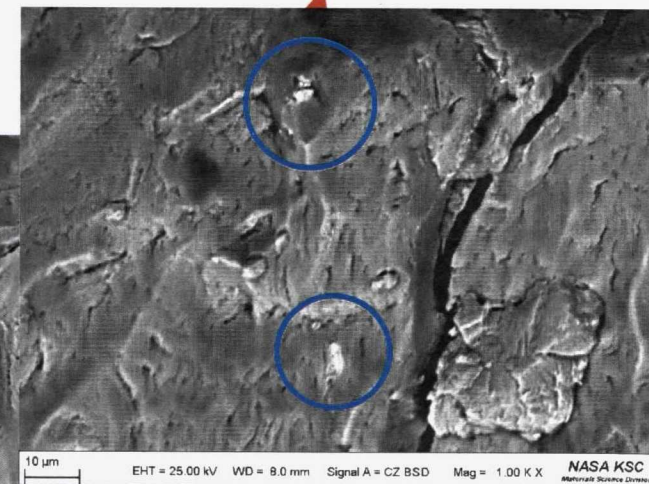
SEM images showing the 3-dimensional topography of the SARJ fragments. Note the relatively flat fracture path and the sharp, perpendicular edges.

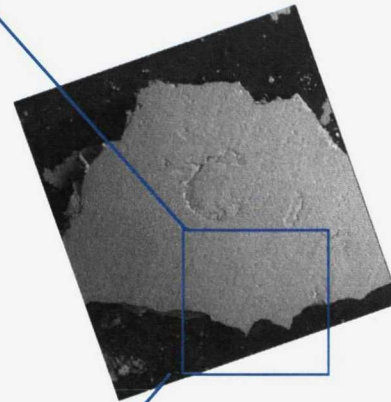
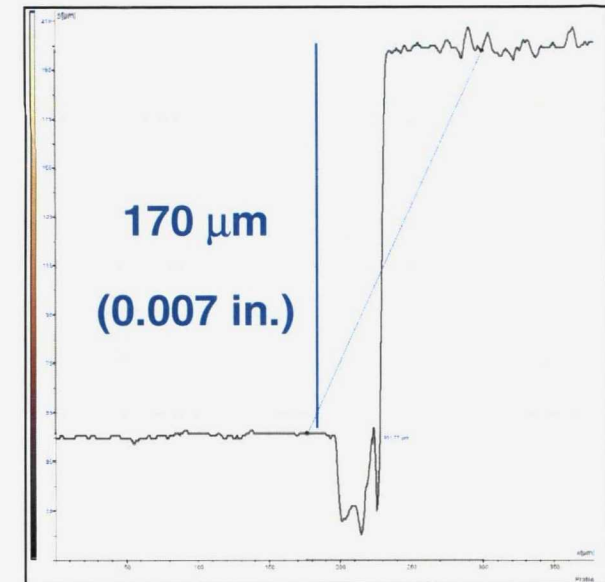
Typical confocal topographical images (2D, 3D) and resulting chart.

Confocal microscopy was used for in-situ (non-destructive) thickness measurements at 100X magnification of several particles.

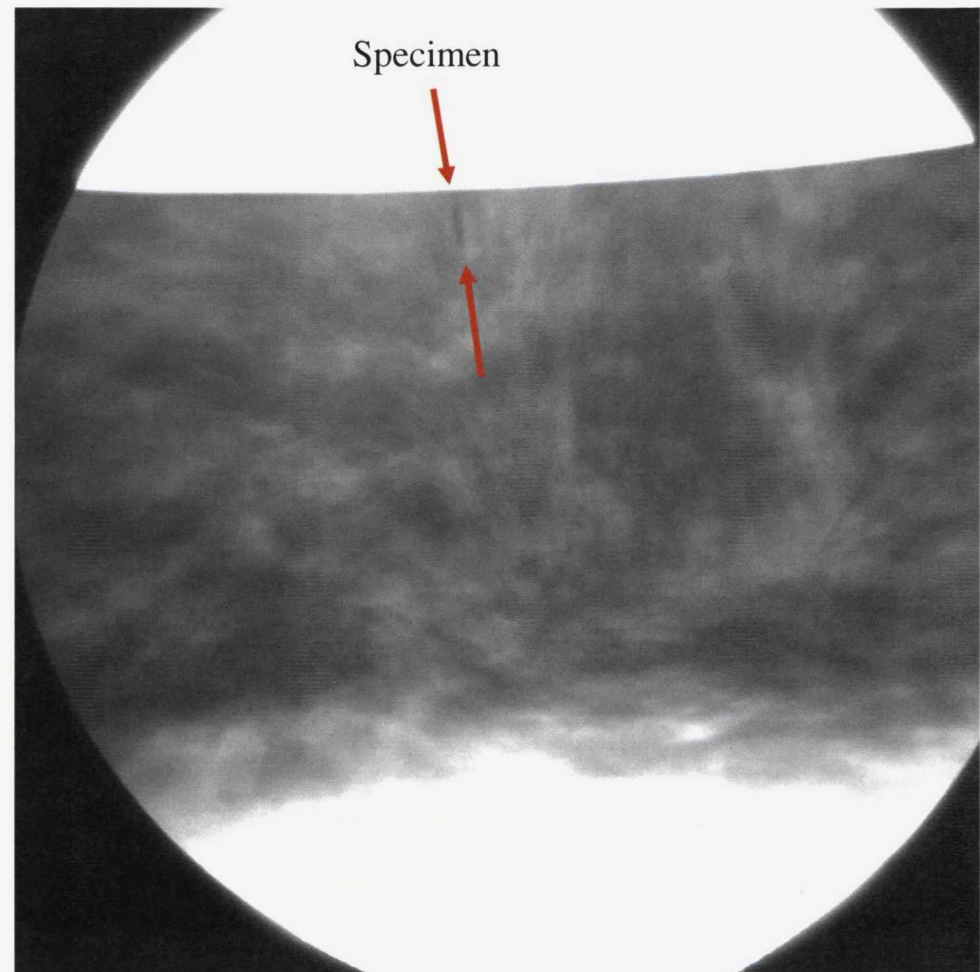
500X

Typical nitrided  
stainless steel.

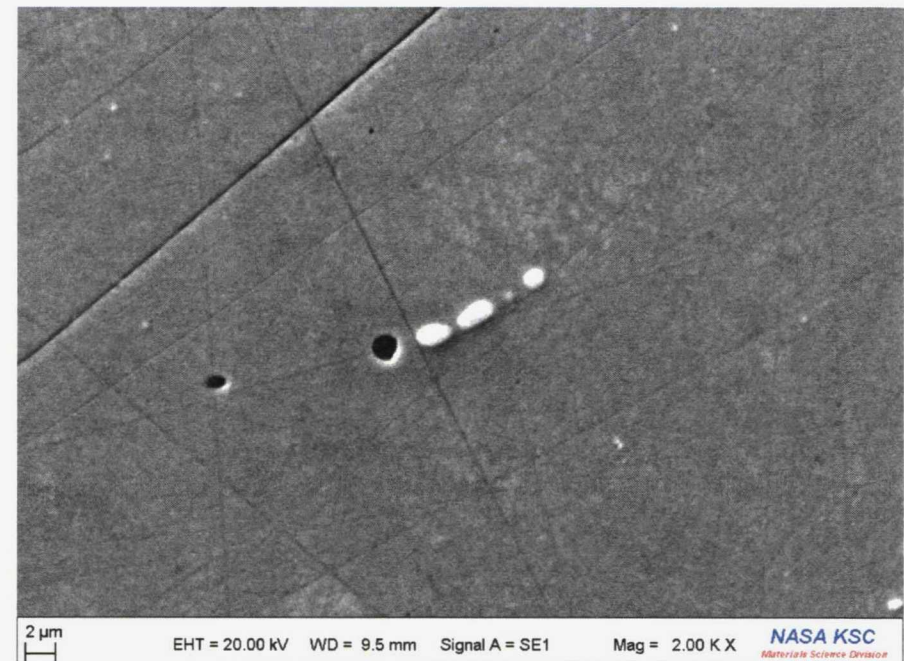
Stock 15-5PH

The precipitates in the SARJ fragment were similar in size and distribution to stock 15-5 PH stainless steel.
